**SERVICE INFORMATION**

Bulletin Nbr: 811-2100

**Noise from the door window glide rollers**

All Saab 9-3 Convertible M98 - M99 up to and incl. chassis no. X7057279.

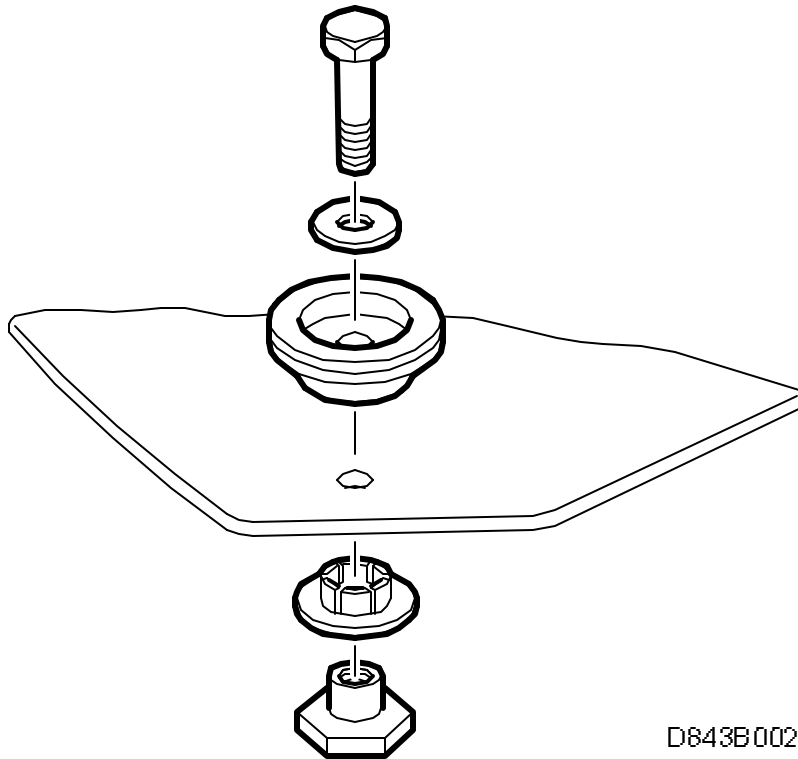
On certain cars, the friction in the glide rollers can cause high-frequency creaking noise. In case of customer complaints, change the glide rollers to new rollers with the following part number.

2. Lay the window glass on a soft and level surface.
3. Remove the glide rollers. Loosen the screw (hold the nut on the rear of the window). Remove the glide roller.
4. Fit the new glide rollers part no. 51 13 436. Tighten the screws.

**Tightening torque : 9 Nm (6.7 lbf ft)**
