MODIFICATION INSTRUCTION	
Bulletin Nbr:	890-2264
Date:Juni 2000
Market:	US,CA

Damage to paintwork on sill under rear left door

Customer satisfaction campaign 118 05

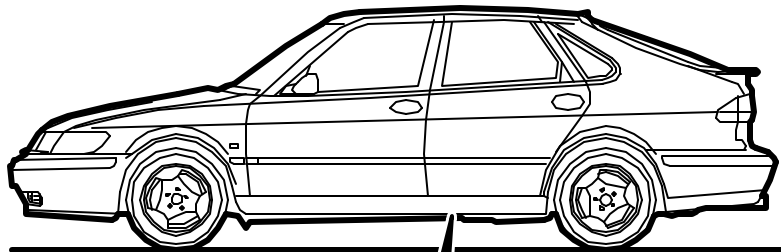
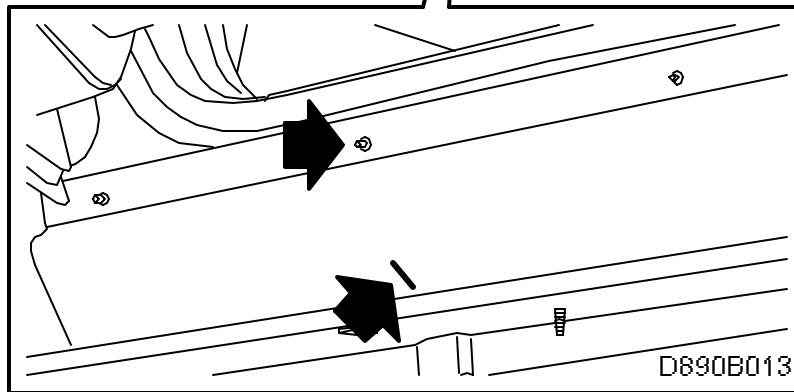
The sill under the rear left door has been scratched in production. The scratch is 2 cm long and is located under the third weld screw from the bottom.

Damage to paintwork on sill under rear left door.

1. Remove the left-hand scuff plate, see WIS - Exterior - Adjustment/replacement - Outer scuff plate 5D and Outer scuff plate sports package/Aero 5D.
2. Thoroughly wipe the damaged area with cleaning agent, Cleaner Teroson FL T875.
3. If the damage has penetrated down to the ED layer or the metal, Standox etching primer must be applied to the damaged area. Allow the primer to air-dry for 10 minutes.
4. Apply the base paint to the damaged area and allow it to air-dry for 10 minutes.
5. Apply clear enamel to metallic base paint. Do not apply clear enamel to solid paints.
6. Fit the scuff plate, see WIS - Exterior - Adjustment/replacement - Outer scuff plate 5D and Outer scuff plate sports package/Aero 5D.
