SERVICE INFORMATION

Bulletin Nbr: 811-2100

Noise from the door window glide rollers

All Saab 9-3 Convertible M98 - M99 up to and incl. chassis no. X7057279.

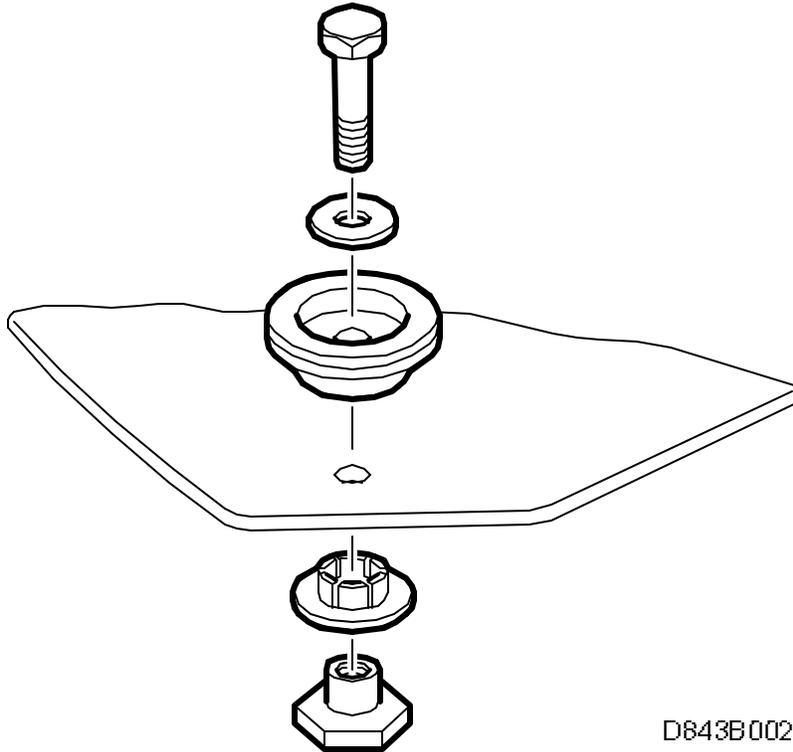
On certain cars, the friction in the glide rollers can cause high-frequency creaking noise. In case of customer complaints, change the glide rollers to new rollers with the following part number.

51 13 436 Glide roller dark grey (4 pcs/car)

2. Lay the window glass on a soft and level surface.
3. Remove the glide rollers. Loosen the screw (hold the nut on the rear of the window). Remove the glide roller.
4. Fit the new glide rollers part no. 51 13 436. Tighten the screws.

Tightening torque : 9 Nm (6.7 lbf ft)
