**SERVICE INFORMATION**

**Number:** 254-1499

**Noise from secondary air injection pump**

Saab 900 M1994 with secondary air injection

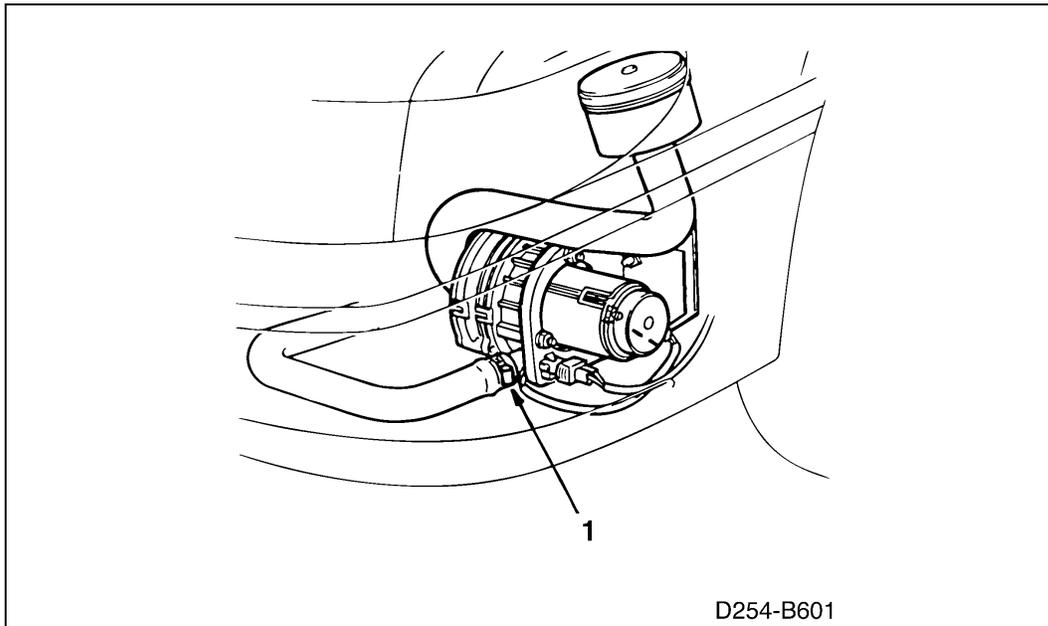
In certain cars with secondary air injection, the sound of the air pump can be disturbing. This can be due to the hose clamp (1) resting against the air shield. In the case of customer complaint, the following action can be taken.

- 1 Undo and turn the hose clamp on the out hose from the air pump so that it is 2-3 mm from nearby parts.
- 2 Tighten the hose clamp. Start the engine and check that the noise has lessened/disappeared.
