SERVICE INFORMATION

Number: 987-1585 UTG. 2

Error in fitting instructions 75 02 24 for the Saab compact heater

Saab 900 M94-.

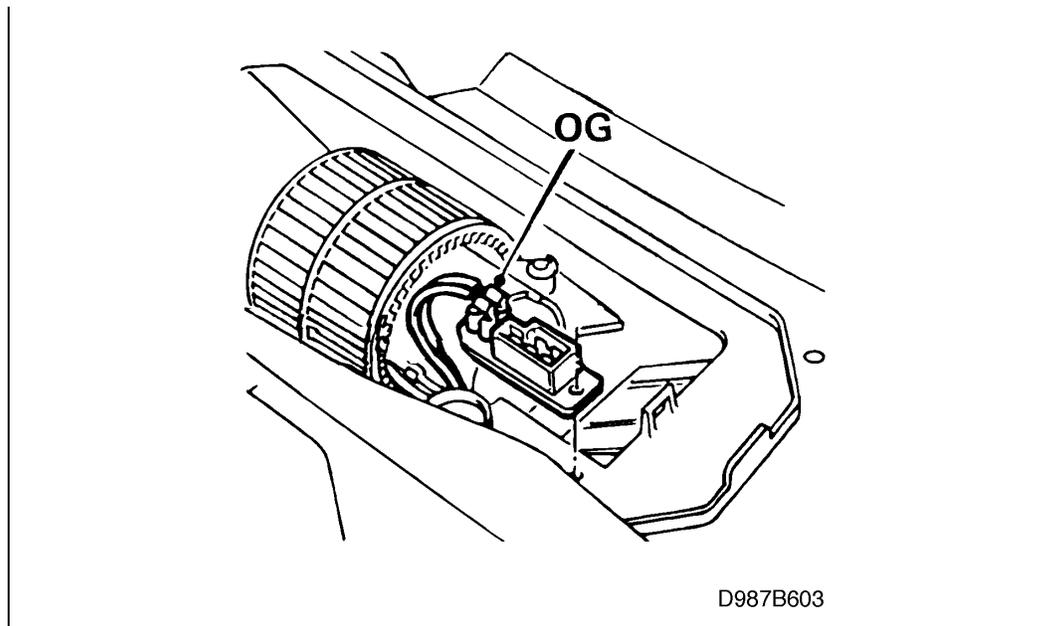
D987B603

In point 39 of the fitting instructions, the colours of the leads in the diagram are labelled incorrectly. The text is correct.

The orange lead mentioned in point 39 of the fitting instructions is connected between the motor and the plate with the 5- pin connector.

Cars on which installation has been carried out as described in edition 1 must be rectified in accordance with this edition.
